Manhole Inspection Summary

Manhole # S25M__035MH

Location Address: **1129 SARGEANT-WASHINGTON ALLEY**

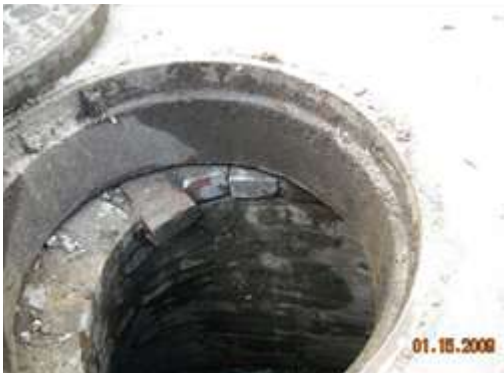
Defect

Subject To Ponding: **Sheeting**

INFLOW EVIDENCE FROM SHEETING

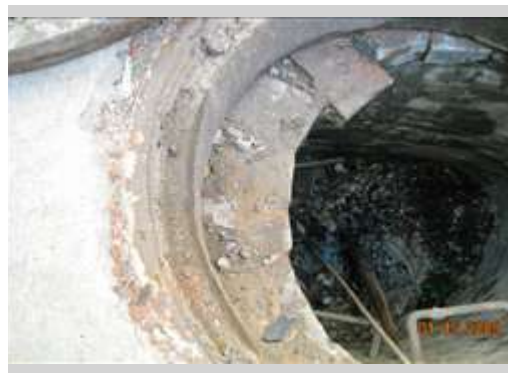
Defect 1

Offset: **7** (in.)

Condition: ☐ Sound ☐ Cracked ☒ **Leaks**

FRAME OFFSET

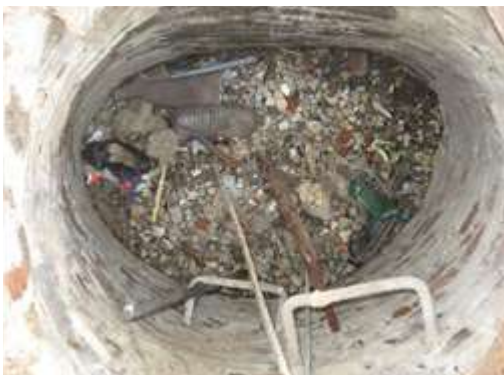
Defect 2

Condition: ☐ Sound ☐ Cracked ☐ Root Intrusion ☐ Deteriorated ☐ Leaks ☒ **Debris**

Debris in the manhole

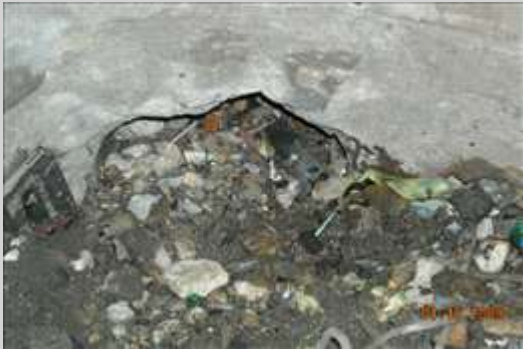
12 O'Clock Outflow

8 in. Circular Gravity Sewer
Pipe Out @ 12 O'Clock

Deposits: ☐ None ☒ **Mud** ☐ Sludge ☒ **Debris** ☐ Grease

Silt Depth: **2** (in.) Deposits Extent: **Medium**
